## **Whitchurch Bridge Company**

### Toll Application Dated 31 October 2008

Proof of Evidence – Martin Brain, Oxfordshire County Council

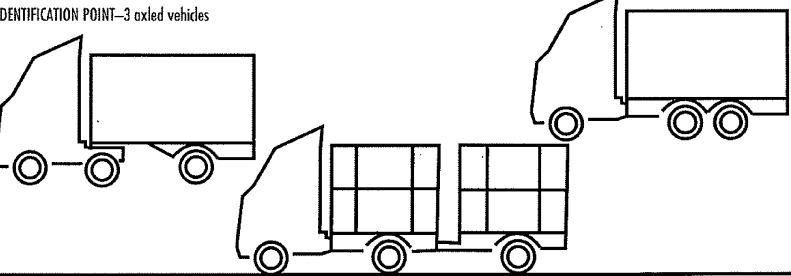
Figure 7.1: Vehical categories used for survey purposes.

or LONG VEHICLE REFLECTIVE PLATES

ARTICULATED (A3)	IDENTIFICATION POINT-3 axled vehicles

More than 7.5 tonne gw
OTHER GOODS VEHICLES 2	RIGID (R4 + 1)	IDENTIFICATION POINT-4 or more axles plus reflective plate on rear

- 6.8 A 3t restriction would limit use of the bridge to cars and light vehicles only (see Fig. 7.1 from Transport in the Urban Environment published by The Institution of Highways & Transportation). Heavier delivery vehicles, together with public service vehicles and buses
